DEPARTMENT OF TRANSPORTATION

Quality Assurance and Source Inspection

Contract #: 04-0120F4Cty: SF/ALA Rte: 80 PM: 13.2/13.9File #: 69.28**WELDING INSPECTION REPORT****Resident Engineer:**Siegenthaler, Peter**Address:** 333 Burma Road**City:** Oakland, CA 94607**Report No:** WIR-022927**Date Inspected:** 09-Apr-2011**Project Name:** SAS Superstructure**OSM Arrival Time:** 700**Prime Contractor:** American Bridge/Fluor Enterprises, a JV**OSM Departure Time:** 1900**Contractor:** Zhenhua Port Machinery Corporation, Ltd (ZPMC), Changxing Island **Location:** Shanghai, China**CWI Name:** Mr. Mai Quin Li**CWI Present:** Yes No**Inspected CWI report:** Yes No N/A**Rod Oven in Use:** Yes No N/A**Electrode to specification:** Yes No N/A**Weld Procedures Followed:** Yes No N/A**Qualified Welders:** Yes No N/A**Verified Joint Fit-up:** Yes No N/A**Approved Drawings:** Yes No N/A**Approved WPS:** Yes No N/A**Delayed / Cancelled:** Yes No N/A**Bridge No:** 34-0006**Component:** Steel Barriers & Handrail**Summary of Items Observed:**

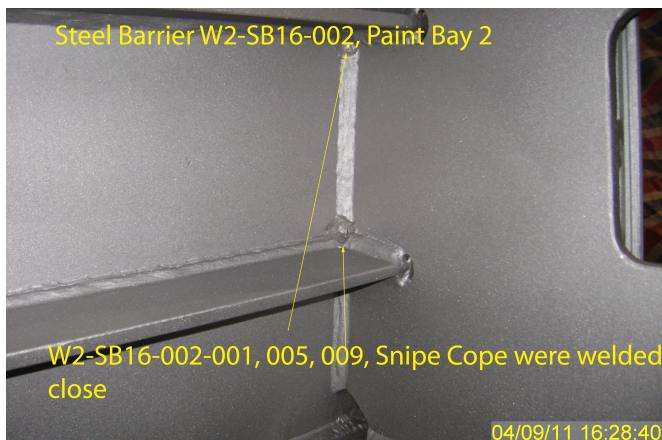
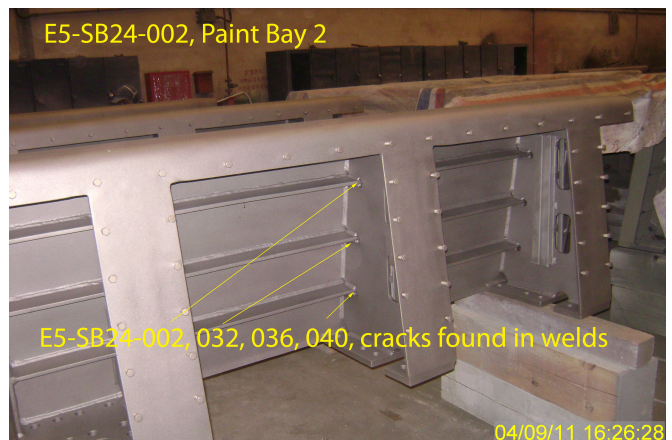
The sniped areas of the rib plate to diaphragm on the Steel Barrier W2-SB16-002 were seal welded which were not in compliance with the correct documents. The area of the snipe access holes shall have an opening of six (6)mm. The welds were identified as W2-SB16-002-001, 002, 003, 004, 005, 006, 007, 008, 009, 010, 011, 012, 032, 033, 034, 035, 036, 037, 038, 039, 040, 041, 042, 063, 064, 065, 066, 067, 069, 070, 071, 072, 073, 074.

The rib plate to front shell plate on Steel Barrier W2-SB24-001, fillet weld is not in compliance with the contract documents. The area of the fillet weld is W2-SB24-001-128, and has excess porosity.

Longitudinal Linear Indication (LLI) located the end of the welds also were visually observed the welds of rib plate to diaphragm on steel barriers identified as W2-SB25-002, E5-SB25-001, E5-SB24-001, W2-SB21-001, W2-SB16-001. These steel barriers were taken back to Bay 16 for repairs.
